Ex Situ Cold Recycled Bound Material

Updates to DMRB CD 226
Stage 1.1.2 - Condition assessment

National Highways

22 November 2022

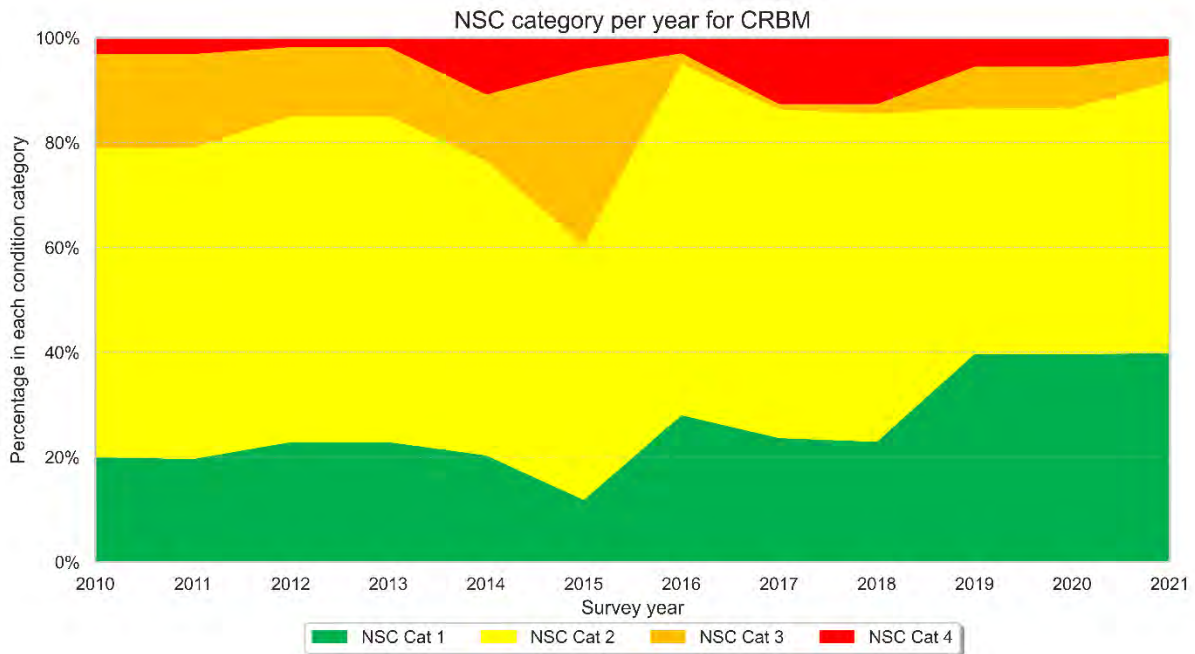
Figure 3.1 - NSC Category per year for 100 m sub-lengths of CRBM

Comparing Figure 3.1 and Figure 3.2, it is apparent that in 2015 there was a significant increase in the NSC categories 3 and 4 reported (i.e. suggesting deterioration) across the SRN. However, the condition quickly recovered in subsequent survey years, which indicates that this is most likely a function of the survey analysis (i.e. a common TSD survey factor or perhaps a common environmental factor) rather than a deterioration in the pavement structural condition that was subsequently treated.

- The NSC category indicates that the candidate CRBM sites are generally consistent with a typical in-service condition and not generally in need of structural maintenance.
- Typically less than 10% of CRBM is in NSC category 3 or 4 in any year, which is aligned with other pavement types on the SRN.

The structural condition of the CRBM sites appears to be broadly stable with the cumulative years and traffic in-service, and there is no apparent deterioration of the structural condition.

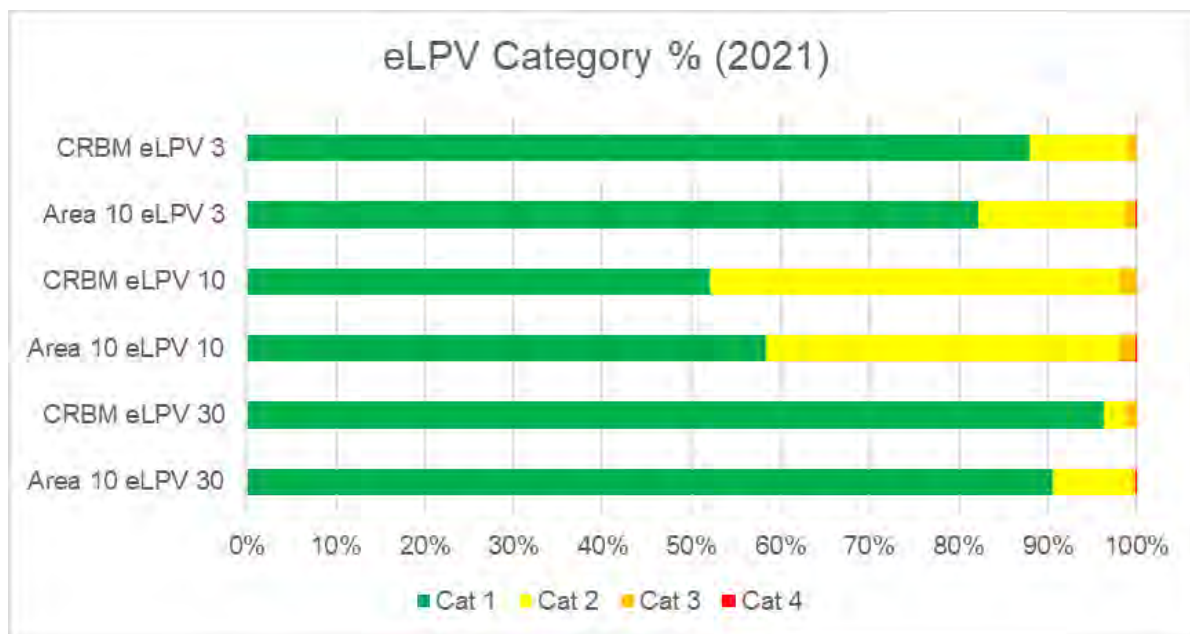
Figure 3.3 - eLPV Category for CRBM (excluding A52 candidate site) and Area 10 network benchmark

Some lengths of the CRBM are in condition category 3 and 4; however, it can be seen in Figure 3.3 that the percentage of lengths in each category are comparable with that of the Area 10 network used as a benchmark. On this basis, it is considered that the profile evenness of the lengths of CRBM is indicative of pavement lengths delivering satisfactory performance and not exhibiting an excessive level of deterioration.

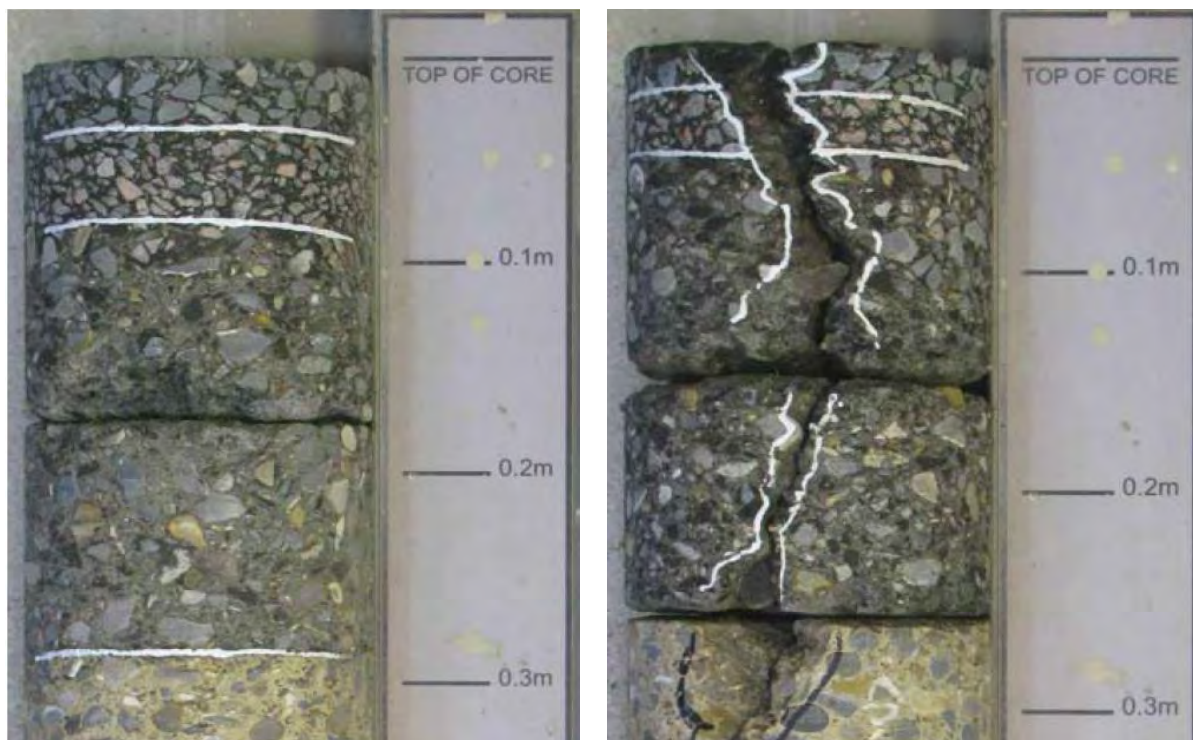
Figure 3.4 - A21 Sevenoaks cores, construction core (left) and defect core (right) (AECOM, 2014)

The condition of the CRBM on this site is documented by Atkins Jacobs JV report Task 1-583 Subtask 3.3 (dated July 2020) (Atkins Jacobs JV, 2020). The site was subject to a factual pavement investigation by AECOM (formerly URS) in 2014. Cores were recovered (representative cores are shown in Figure 3.4) and falling weight deflectometer testing was undertaken; however, cores were not tested for stiffness. The FWD back-analysed stiffness of the CRBM layer averaged 5253 MPa with a minimum of 3400 MPa and a maximum of 7900 MPa.

This suggests the layer is exhibiting 'some deterioration' in accordance with CD 227, as expected of a generally intact in-service asphalt material. Indeed, the cores are intact and the minimum back-analysed stiffness on the site is greater than the design stiffness for a QVE B3 (3100 MPa).

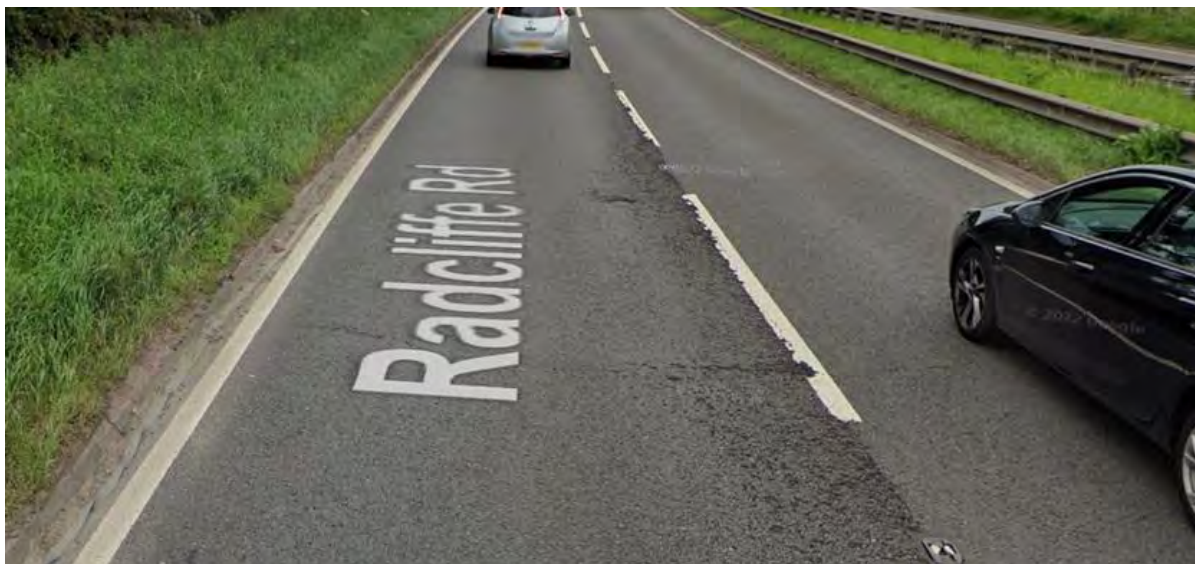
Figure 3.5 - A52 Stragglethorpe Rd to Nottingham Rd transverse cracking and raveling

The NSC categories for the site are indicative of a length of pavement not requiring structural maintenance. eLPV data was not available in HAPMS. The site has not been resurfaced since the installation of the CRBM, so the surfacing is 15 years old. As expected for a site of this age, recent imagery (Google Street View, April 2022) indicates that the surfacing is now showing signs of deterioration including transverse cracking as shown in Figure 3.5, assumed to be propagating from the underlying CRBM.

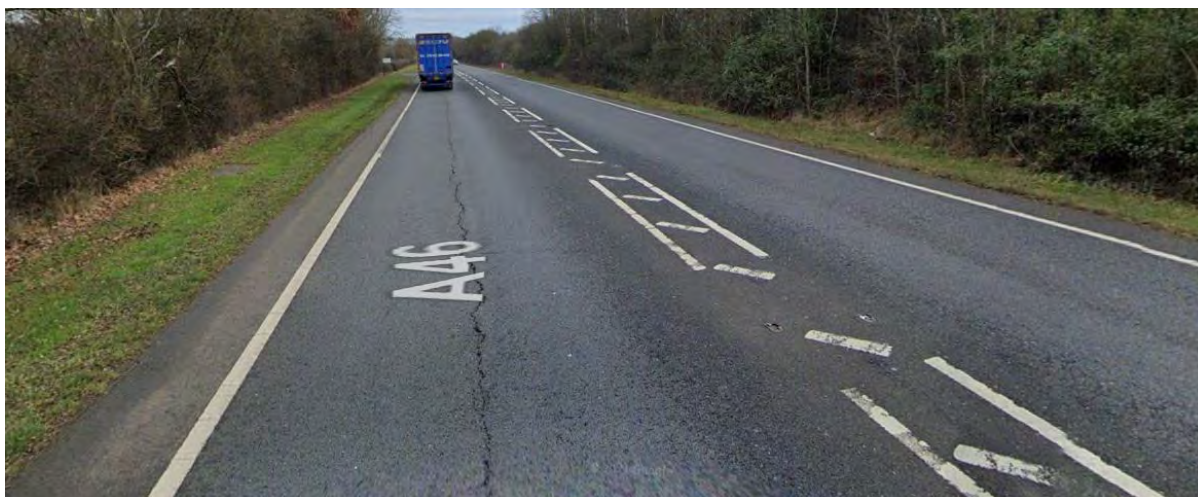
Figure 3.6 - A46 Stratford-upon-Avon Bypass longitudinal cracking from underlying HBM joints

Longitudinal cracking in the asphalt surfacing is prevalent in the lane centres along the site, aligned with the longitudinal construction joints in the HBM which are present in the centre of each lane as shown in Figure 3.6. Longitudinal cracking is not expected to emanate from construction joints through a 230 mm thick flexible layer (combined CRBM and asphalt thickness). However, PPR 228 states that the construction joints at the time of construction of the CRBM were wide (>10 mm) as a result of embankment settlement. Some of these construction joints had been subject to trench repairs with asphalt prior to the crack and seat and CRBM works. Visually, the cracking, located outside the wheel tracks, appears to be consistent with the historical settlement rather than the structural integrity of the pavement layers.

- the underlying cracked and seated HBM layer, and/or
- the CRBM layer, and/or
- the asphalt surfacing, i.e. top-down cracking.

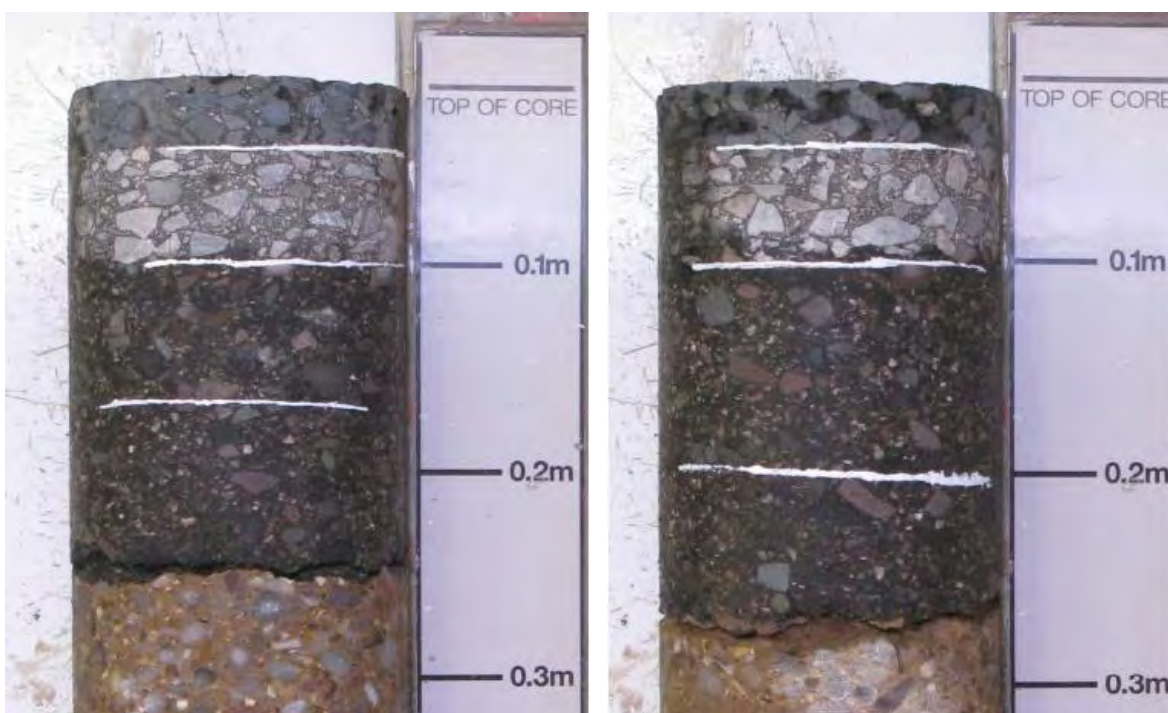
Figure 3.7 - A46 Stratford upon Avon bypass cores from 2019

Cores for this site were taken by AECOM in 2019 and are provided in Appendix A. The cores were taken through sound uncracked surfacing only, and indicate that the CRBM was in good condition and intact as shown in the representative photos in Figure 3.7. On the basis of the above, the CRBM is considered to be performing well.

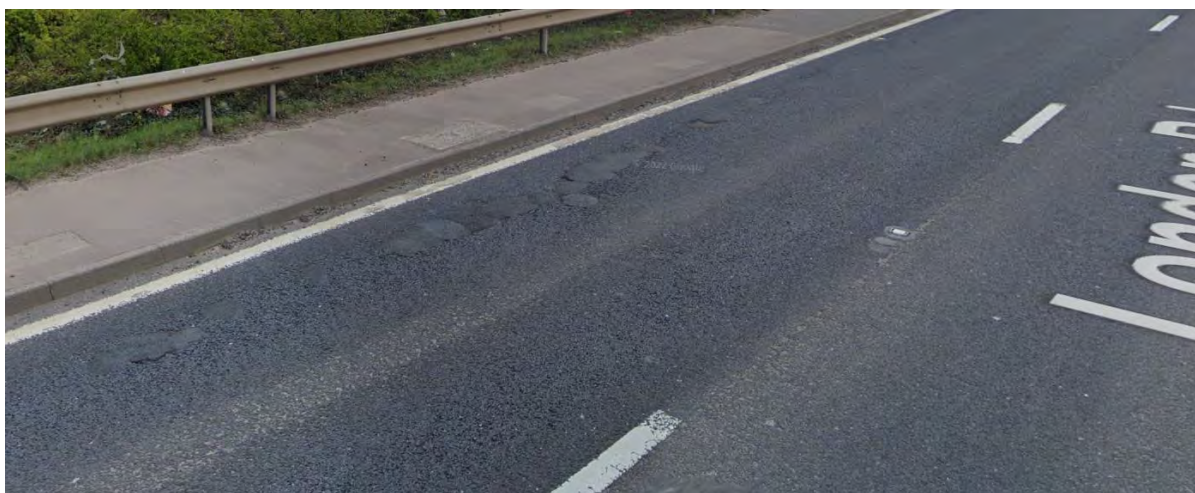
Figure 3.8 - A45 Ryton-on-Dunsmore apparent structural deterioration (Google Street View, 2018)

In contrast, the westbound carriageway is largely free from deterioration and has only had an asphalt patch applied in one location. Other sections on the eastbound are largely free from defects and there is not widespread transverse cracking across the site. This may suggest that the assumed deterioration of the CRBM on the eastbound carriageway is as a result of the local foundation and/or loading conditions.

Intrusive investigation is recommended to gain a better understanding of the condition of the pavement and the cause of the deterioration and the comparative differences between the westbound and eastbound carriageway.
