# Review of alternatives to High Friction Surfacing

Task 1-912 Review of Materials Performance & Texture  
Depth Policy

National Highways

Project number: 60606238

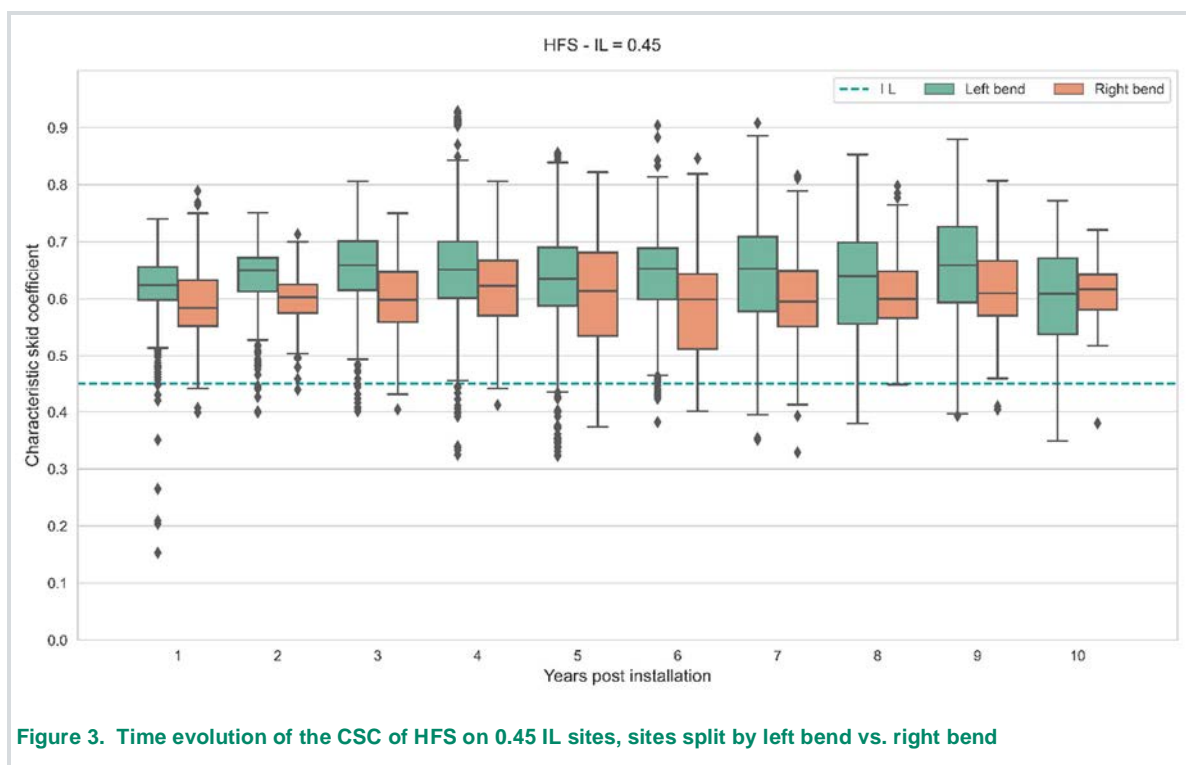
Figure 3. Time evolution of the CSC of HFS on 0.45 IL sites, sites split by left bend vs. right bend

Figure 3 illustrates the CSC on left and right bends for sites with an IL of 0.45. There are substantial differences in the CSC for left bends and right bends. The median and minimum CSC values are lower from years 1 to 6 for right bends. The relative increase in CSC for right bends with service lives of years 7 through 10 can be attributed to fewer sites which perform well over an extended period, whilst lesser performing sites would have been replaced prior to reaching this service life. The right bend data is considered to be representative of the CSC performance of HFS.

Considering the right bend data presented in Figure 3, with the exception of a limited number of outliers, HFS delivers a CSC approximately at or above 0.45 on 0.45 IL sites for up to 4 years. After this point, the minimum values decrease below the 0.45 threshold and data spread increases, whilst the median values remain consistent. This indicates that at year 4, some sites will require investigation to determine whether intervention is required.

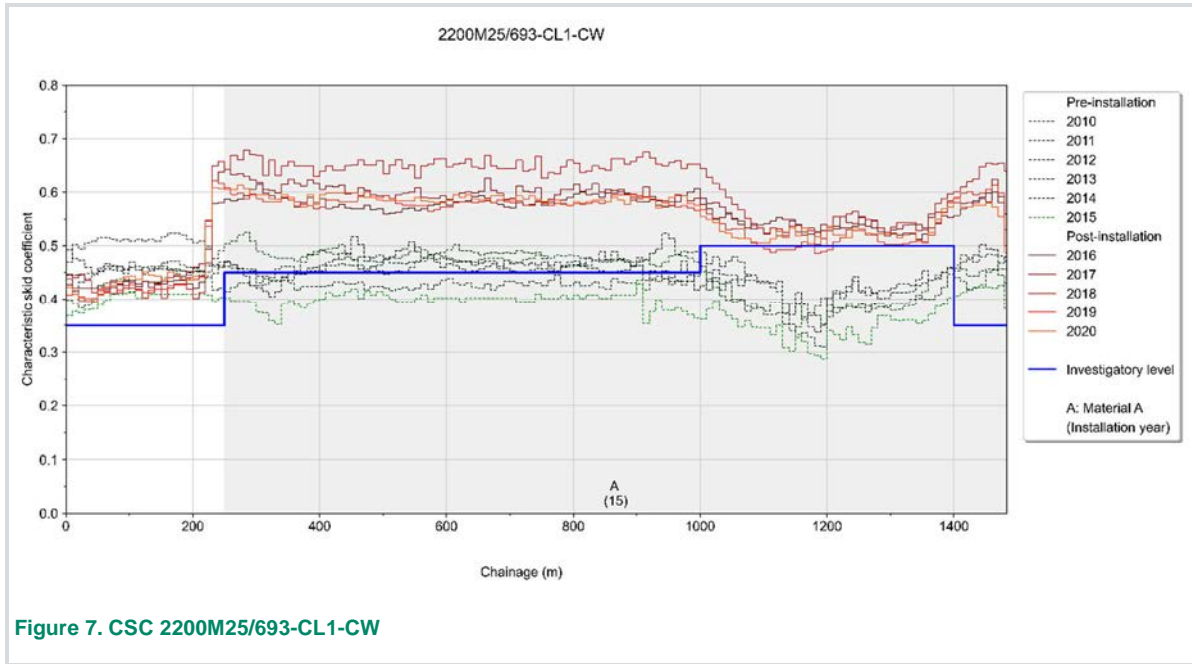
Figure 7. CSC 2200M25/693-CL1-CW

Figure 7 illustrates the time evolution of the CSC for every 10 m length section on HAPMS section 2200M25/693 – CL1. The area highlighted in grey identifies the section where Material A has been installed. As outlined in the figure and Table 3.5, the IL ranges between 0.35, 0.40 and 0.45. From the figure, the following observations can be made:

- The pre-installation material (asphalt) generally fails to meet the required IL thresholds. There is a clear decrease in the CSC between chainages 1,000 m and 1,400 m which is associated with the sharpest part of the right bend.
- The post-installation material (Material A) increases the CSC across the section. The CSC generally meets the required IL thresholds except for the 2020 survey between chainages 1,100 m and 1,200 m. There is a clear decrease in the CSC between chainages 1,000 m and 1,400 m which is associated with the sharpest part of the right bend.

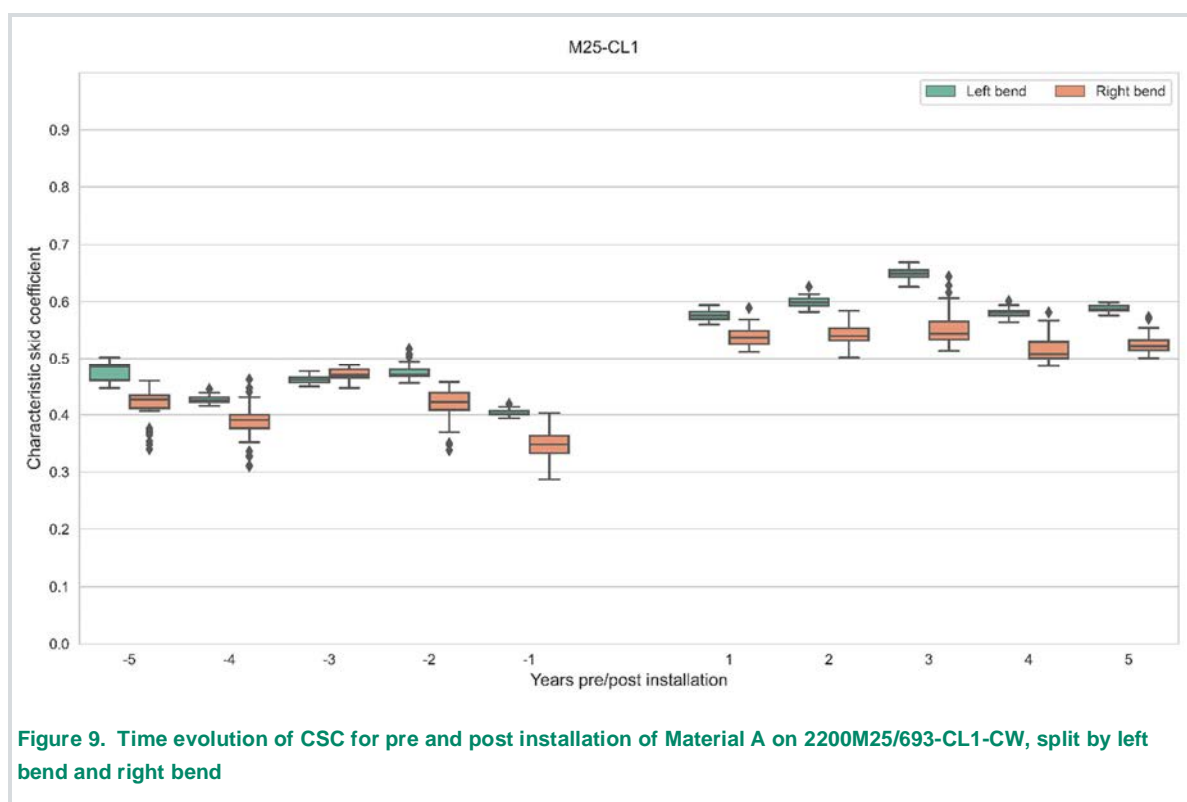
Figure 9. Time evolution of CSC for pre and post installation of Material A on 2200M25/693-CL1-CW, split by left bend and right bend

Figure 9 illustrates the average CSC on the left bend (Ch. 400 – 800) and right bend (Ch. 1000 – 1400). There is a consistent increase in the average CSC values post-installation in both bends. However, the right bend reports lower CSC values both pre-installation and post-installation. The spread of the right bend is relatively larger compared with the left bend indicating lower consistency.

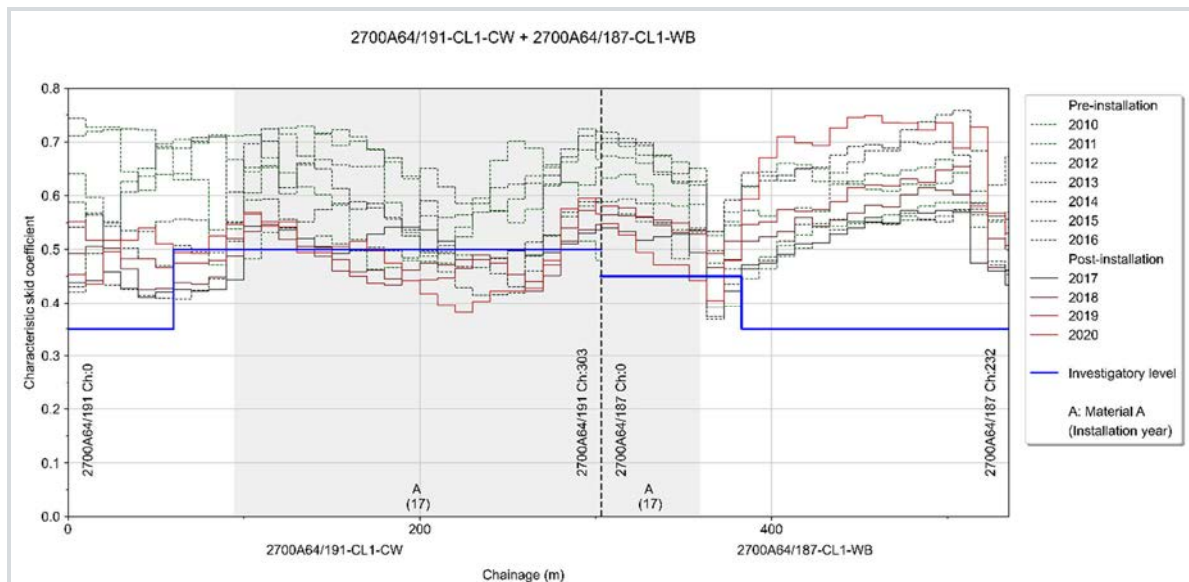
**Figure 12. CSC Entry Slip 2700A64/191-187**

The A64 Askham Bryan entry slip consists of HAPMS sections 2700A64/191-CL1 and 2700A64/187. Figure 12 illustrates the time evolution of the CSC for every 10 m length section on the entry slip. The area highlighted in grey identifies the section with Material A. The IL ranges between 0.45 and 0.5. From Figure 12, the following observations can be made:

- The pre-installation material (HFS - hot applied) generally meets the required IL thresholds. There is no clear correlation between the CSC values and the required IL threshold.
- The post-installation material (Material A) does not result in an increase in the CSC, rather, the CSC values are generally lower than pre-installation.

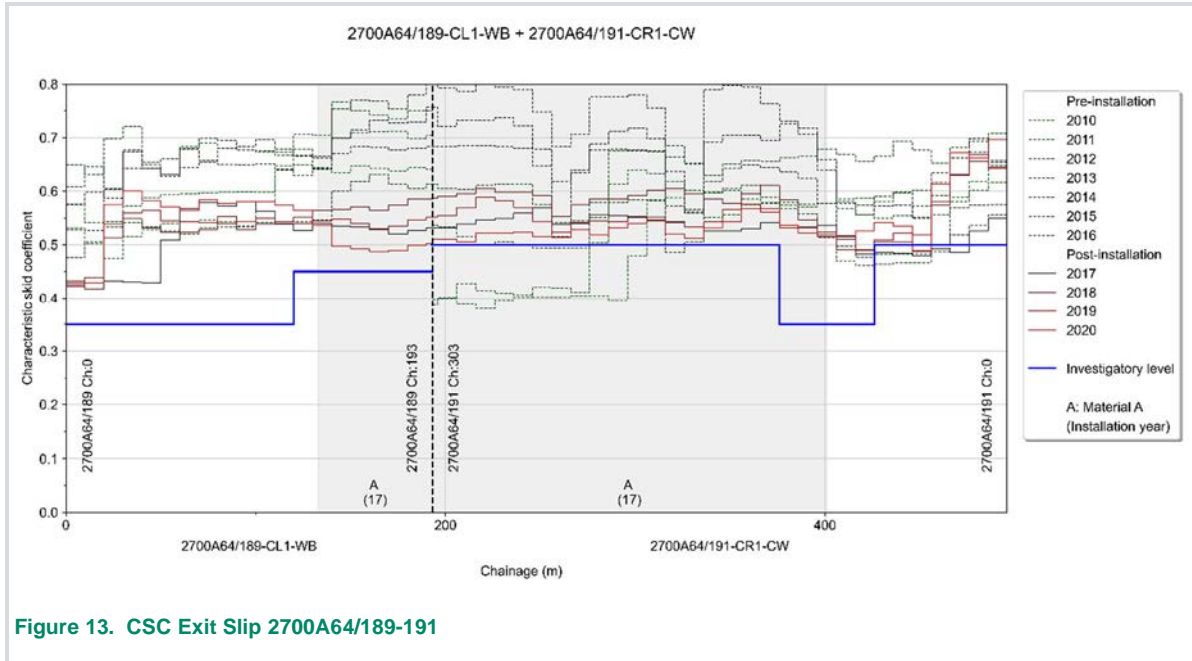
Figure 13. CSC Exit Slip 2700A64/189-191

The A64 Askham Bryan exit slip consists of HAPMS sections 2700A64/189 and 2700A64/191-CR1. Figure 13 illustrates the time evolution of the CSC for every 10 m length section on the exit slip. The area highlighted in grey identifies the section with Material A. The IL ranges between 0.35, 0.45 and 0.5. From Figure 13, the following observations can be made:

- The pre-installation material (HFS - hot applied) generally meets the required IL thresholds except for 2010 and 2011 surveys between site chainages 193 m and 300 m. The site shows no clear correlation between the CSC values and the required IL threshold.
- The post-installation material (Material A) does not result in an increase in the CSC, rather, the CSC values are generally lower than pre-installation.

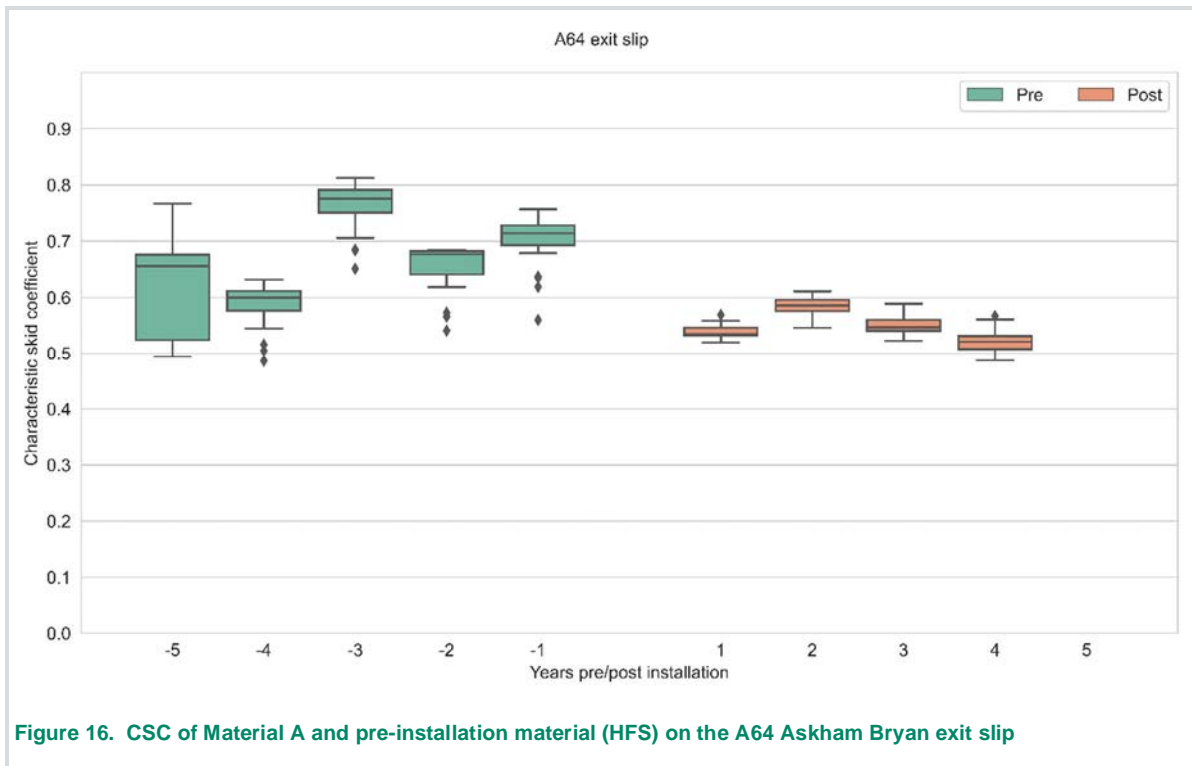
Figure 16. CSC of Material A and pre-installation material (HFS) on the A64 Askham Bryan exit slip

Figure 16 illustrates the time evolution of CSC on the A64 exit slip. There is a decrease in the CSC value post-installation. Minimum CSC values are generally comparable to pre-installation. The exit slip has relatively higher CSC values post-installation, when compared to the entry slip. This could be attributed to the fact that the exit slip has no right turns. The spread of the post-installation values is relatively small indicating higher consistency.

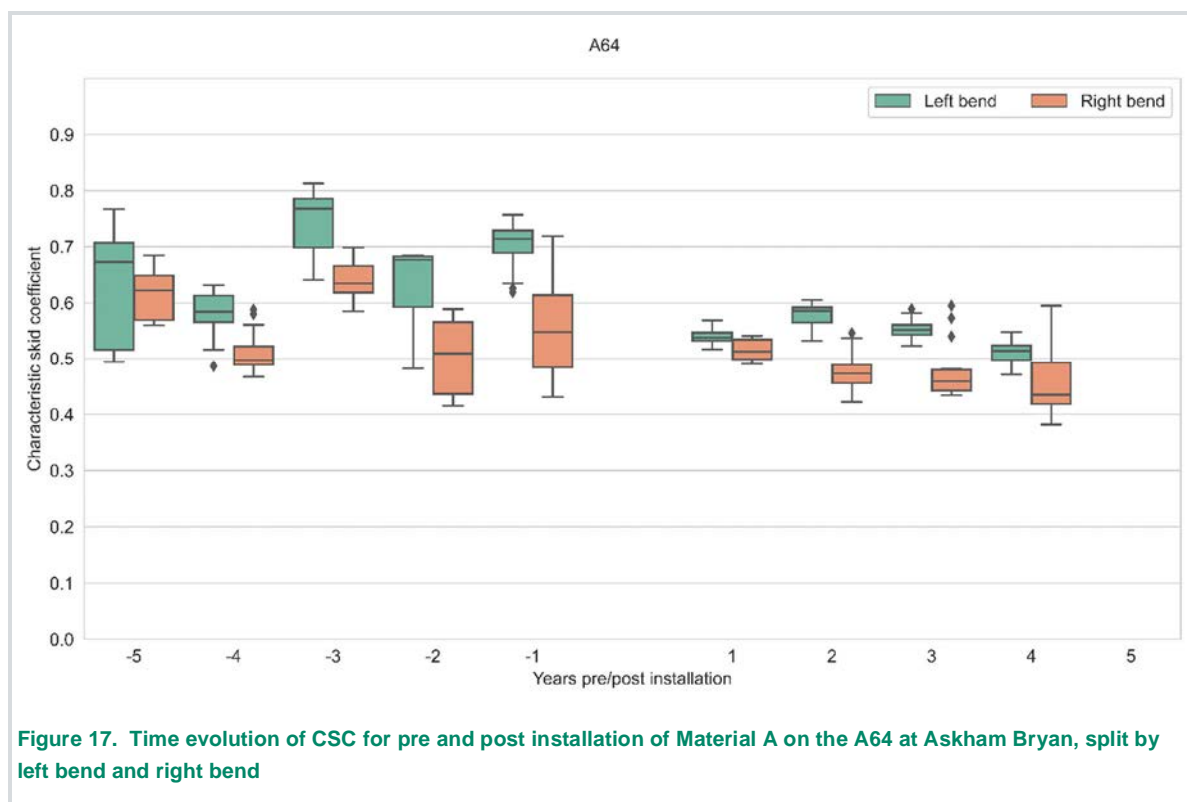
Figure 17. Time evolution of CSC for pre and post installation of Material A on the A64 at Askham Bryan, split by left bend and right bend

Figure 17 illustrates the CSC on left and right bends where the Material A has been applied. The right bend has lower CSC values both pre-installation and post-installation. Both bends report a decrease in the average CSC

values post-installation. However, the lowest CSC values on right bends are initially similar to the lowest values before installation, although they appear to decline further in year 4.

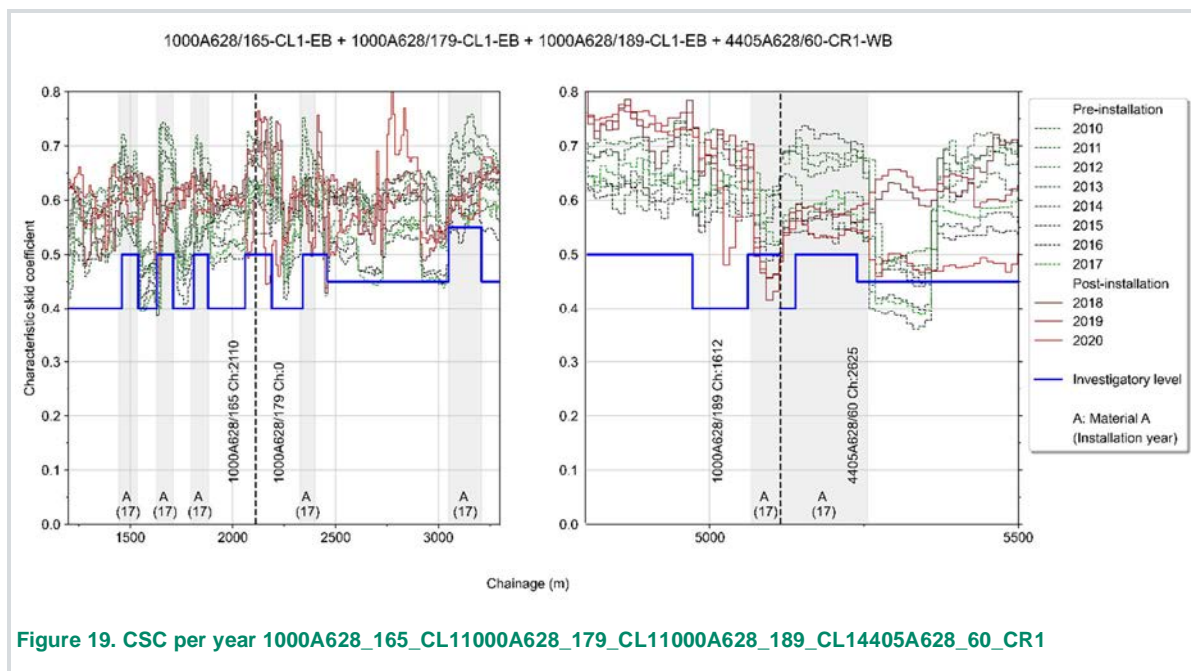
areas highlighted in grey identify the sections with Material A. The IL varies between 0.40, 0.5 and 0.55. From the figure, the following observations can be made:

- The pre-installation material (HFS – hot applied) generally meets the required IL thresholds. There is some type of correlation between the CSC values and the required IL threshold especially for sections on 1000A628/165 and 1000A628/179.
- The post-installation material (Material A) generally meets the required IL thresholds, with the exception of a localised length at approx. cumulative chainage 5100 m (1000A628/189 Ch. 1565 – 1612). The CSC values are generally within the range of the pre-installation material.

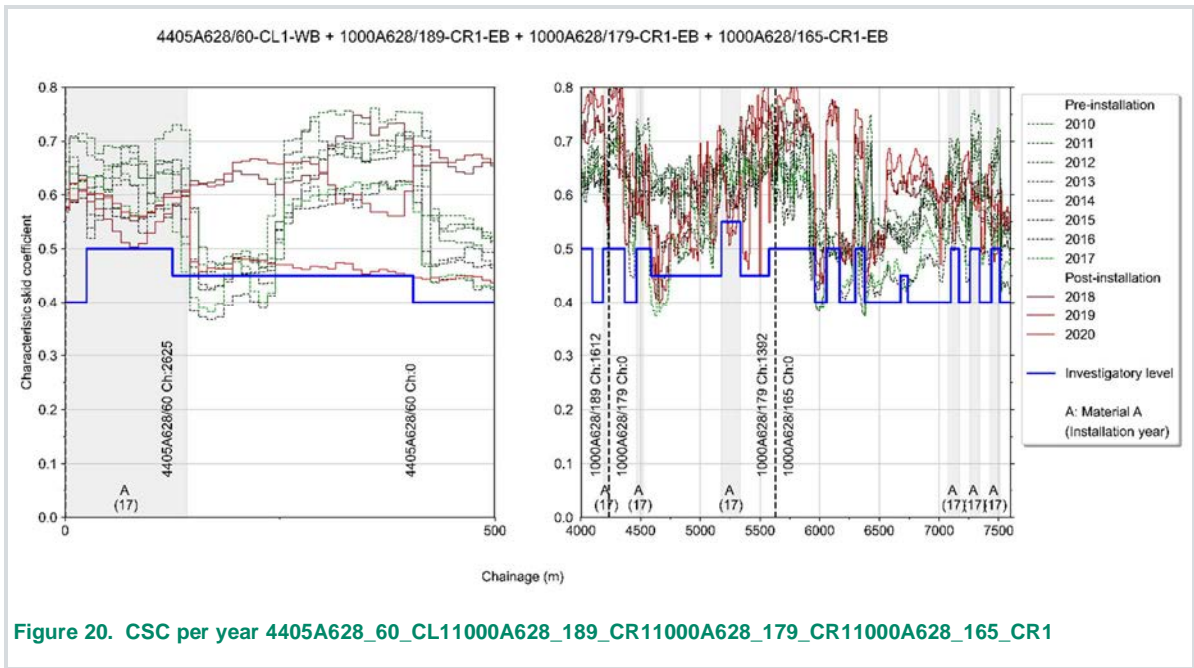
The A628 westbound site consists of HAPMS sections 4405A628/60-CL1, 1000A628/189- CR1, 1000A628/179- CR1 and 1000A628/165-CR1. Figure 20 illustrates the time evolution of the CSC for every 10 m length section. The areas highlighted in grey identify the section with Material A. The IL ranges between 0.4, 0.5 and 0.55. From the figure, the following observations can be made:

- The pre-installation material (HFS – hot applied) generally meets the required IL thresholds. There is some type of correlation between the CSC values and the required IL threshold especially for sections on 1000A628/165 and 1000A628/179.
- The post-installation material (Material A) generally meets the required IL thresholds, with the exception of a localised length different to the eastbound direction at approx. cumulative chainage 5250 m (1000A628/179 Ch. 950 – 1000). The CSC values are generally within the range of the pre-installation material.

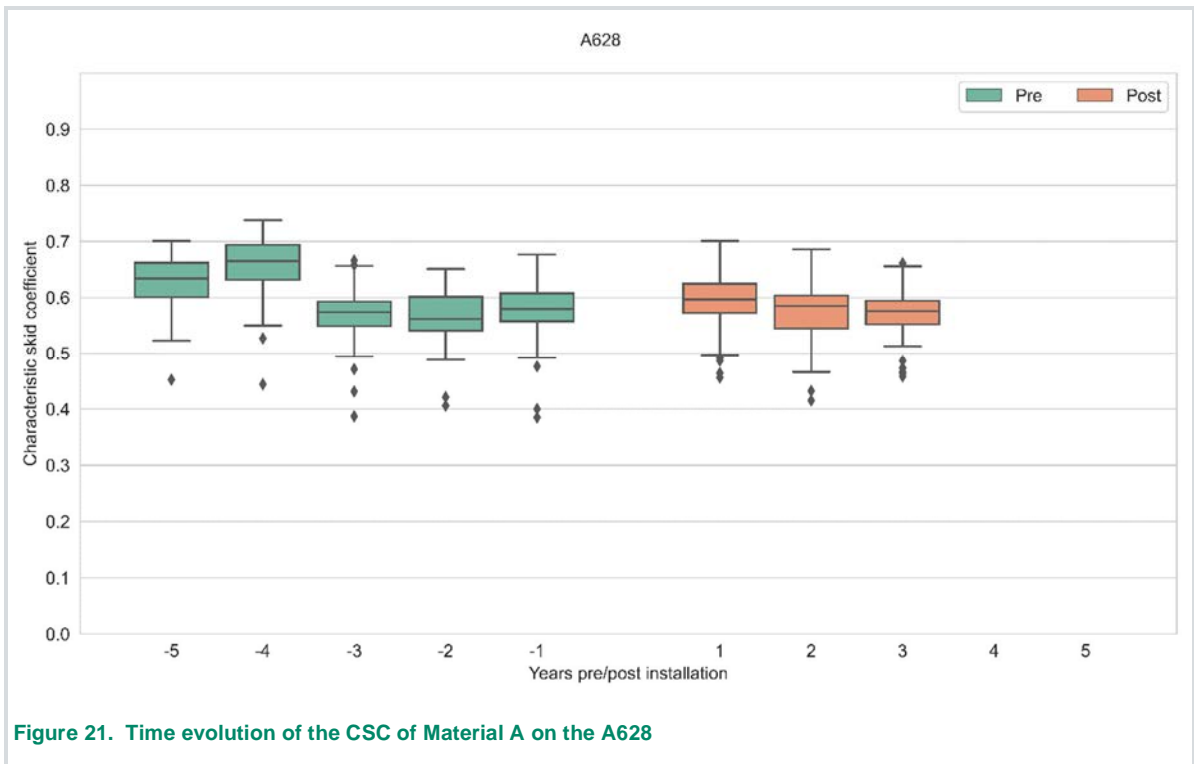
Figure 21 illustrates the time evolution of the CSC of Material A on the A628 site. Pre-installation and post-installation materials have similar average CSC values. However, minimum CSC values are relatively lower in the pre-installation HFS.

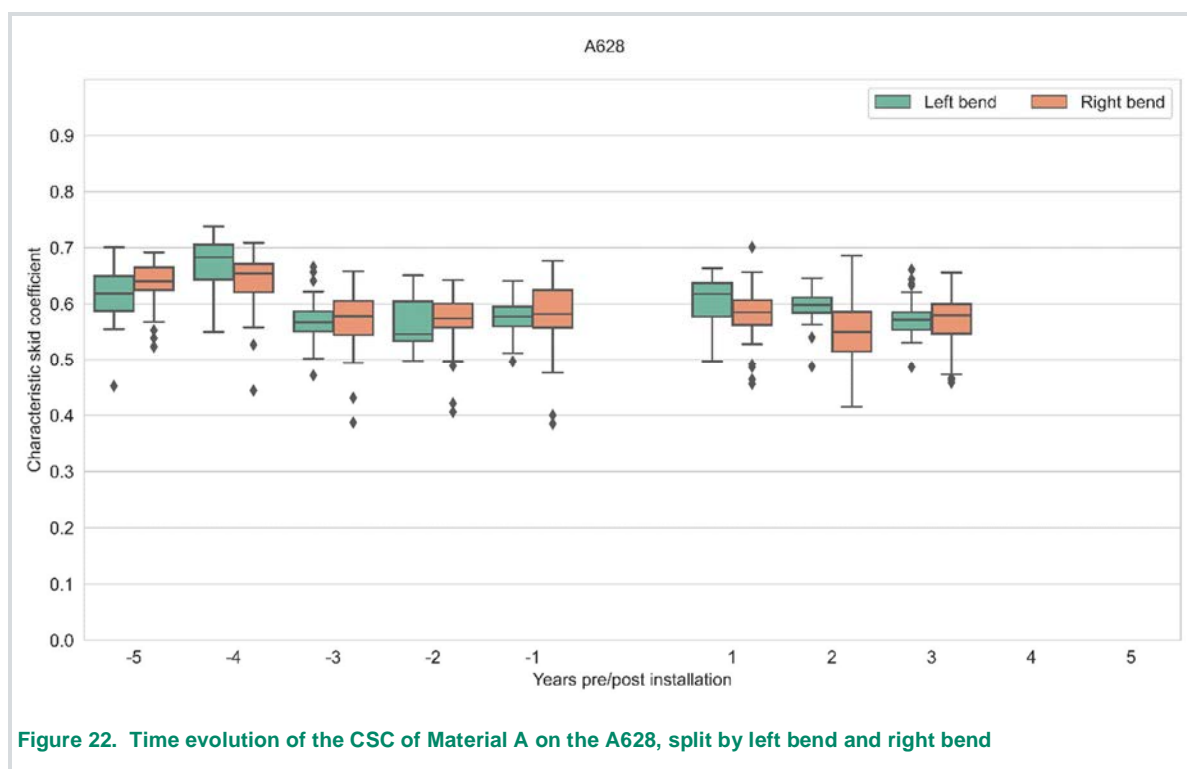
Figure 22. Time evolution of the CSC of Material A on the A628, split by left bend and right bend

Figure 22 illustrates the average CSC on left and right bends. There is no clear difference in the median CSC values between right and left bends. However, right bends report relatively lower minimum CSC values. Right bends have also more outliers, indicating lower consistency.

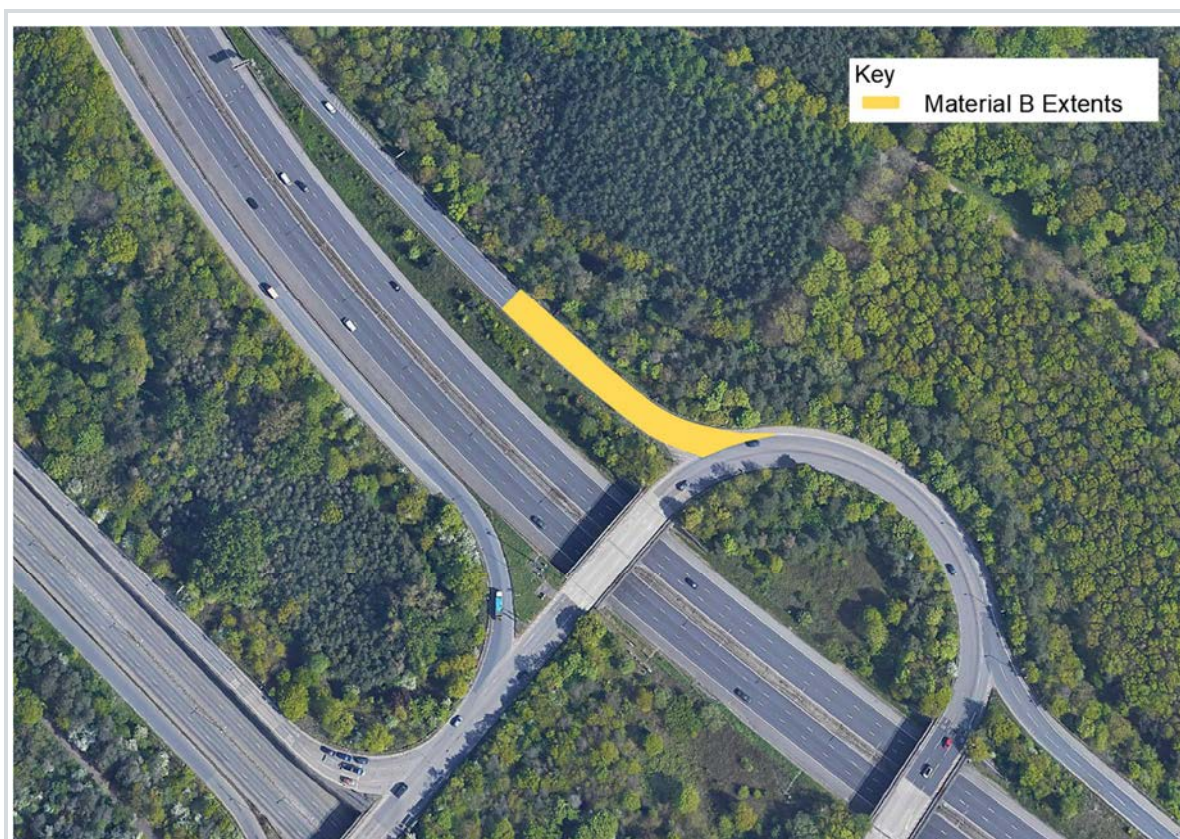
Figure 23. M1 J5 SB Site extents

The HAPMS section 1900M1/89 is a slip road located on the M1 J5 SB as shown in Figure 23. It is a one-way carriageway with a total length of 528 m. Material B is applied between chainages 440 m and 528 m on CL1 on the approach to a signalised junction. Traffic count information and the minimum PSV for the site are outlined in Table 3.10.

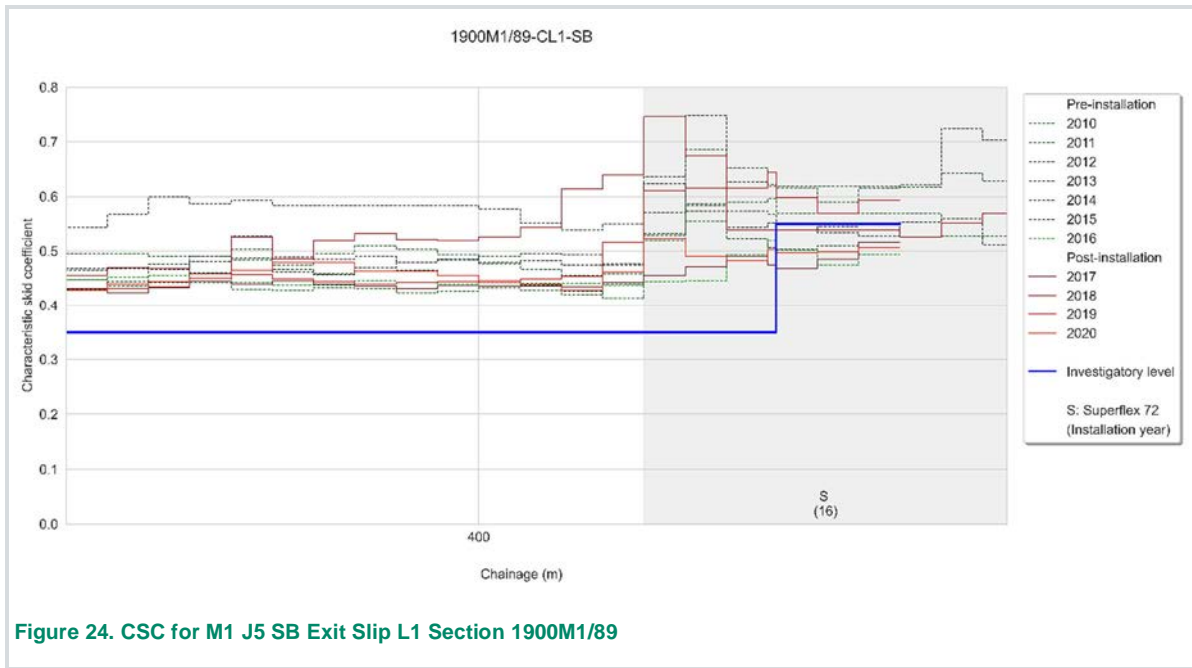
Figure 24. CSC for M1 J5 SB Exit Slip L1 Section 1900M1/89

Figure 24 illustrates the time evolution of the CSC for every 10 m length section for chart section 1900M1/89. The area highlighted in grey identifies the section with Material B. The IL ranges between 0.35 and 0.55. The pre-installation material is asphalt. From the figure, the following observations can be made:

- The pre-installation material (asphalt) meets the required 0.35 IL threshold but generally fails to meet the 0.55 threshold.
- Material B is not associated with an increase in the CSC across the section. The section meets the required 0.35 IL threshold but generally fails to meet the 0.55 threshold.

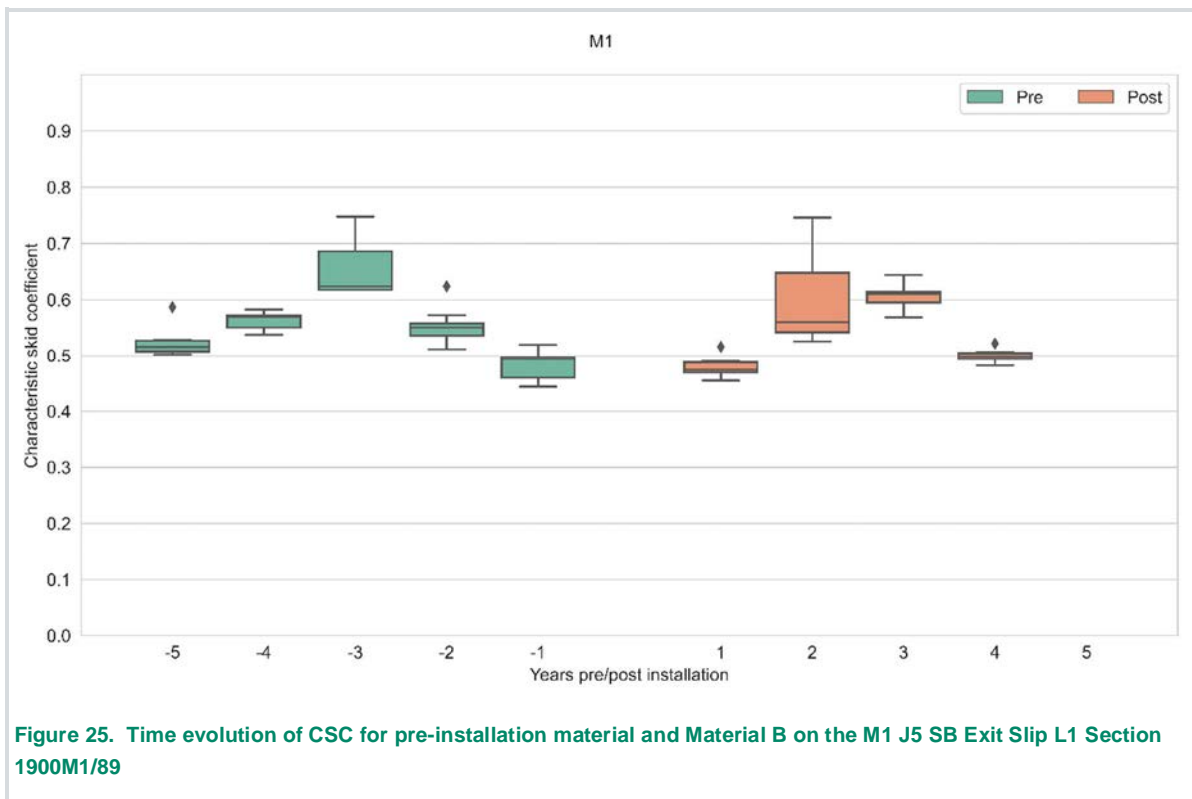
Figure 25. Time evolution of CSC for pre-installation material and Material B on the M1 J5 SB Exit Slip L1 Section 1900M1/89

Figure 25 illustrates the time evolution of CSC of Material B and pre-installation material on the site. The post-installation CSC is considerably lower than the IL in year 1, with most CSC values being below 0.5 IL. This could be due to the presence of the binder film on the aggregate. The post-installation material shows comparatively better performance in years 2 and 3, with all recorded CSC values being above 0.5 IL, but then reduces in year 4. This aligns with other reported studies of the skid resistance of high-PSV materials (Stephenson, Hodgson, & Premathilaka, 2014). The CSC post-installation is comparable to the values reported pre-installation. Since the pre-installation material is asphalt, Material B does not appear to provide any improvement in CSC on this section versus conventional asphalt. However, as the post-installation data is limited, it is difficult to make any meaningful judgment on the performance of the post-installation material.

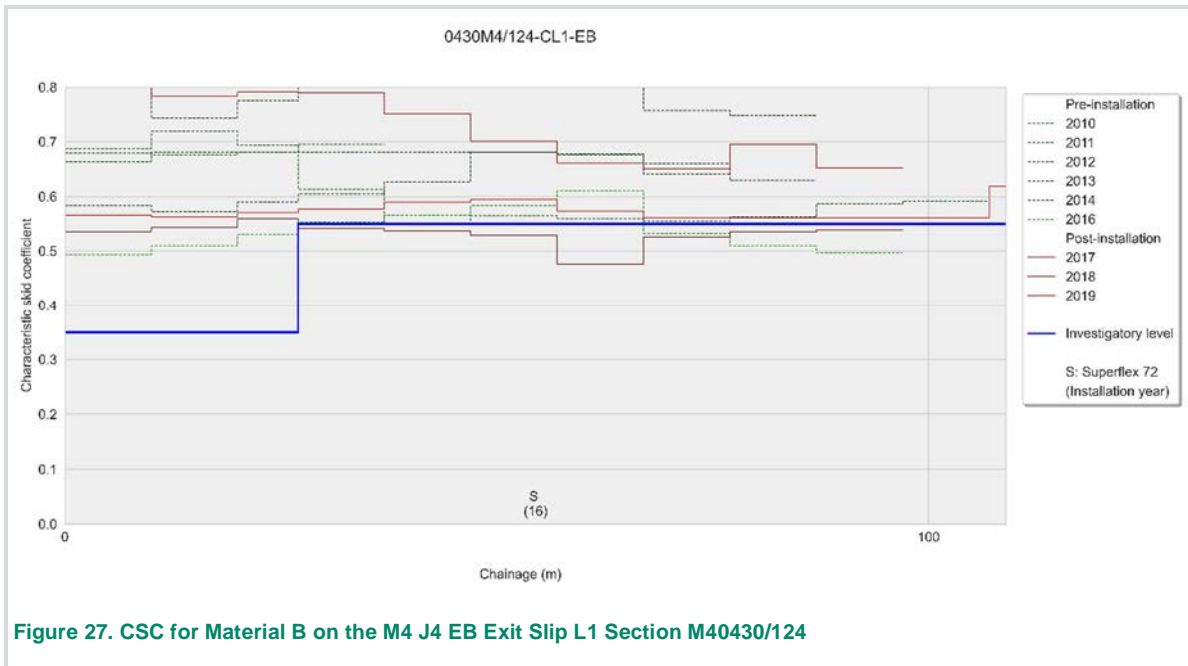
Figure 27. CSC for Material B on the M4 J4 EB Exit Slip L1 Section M40430/124

Figure 27 illustrates the time evolution of the CSC for every 10 m length section. The area highlighted in grey identifies the section with Material B. In this case, the entire section is surfaced with Material B. The IL ranges between 0.35 and 0.55. The pre-installation material was HFS. From the figure, the following observations can be made:

- The pre-installation material (HFS - hot applied) meets the required 0.35 IL threshold, but generally fails to meet the 0.55 IL threshold.
- Material B is not associated with an increase in the CSC across the section.

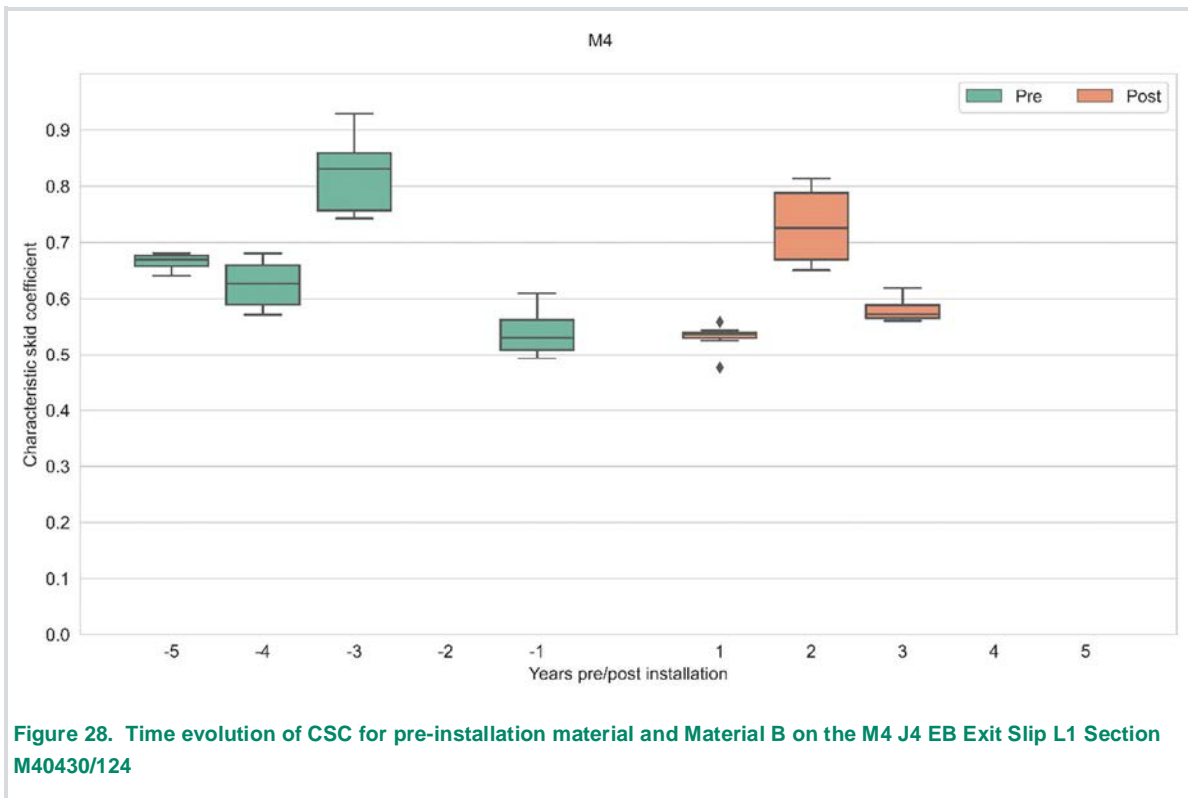
Figure 28. Time evolution of CSC for pre-installation material and Material B on the M4 J4 EB Exit Slip L1 Section M40430/124

Figure 28 illustrates the time evolution of CSC of the Material B and pre-installation material on the site. The post-installation CSC is lower in year 1 when compared with year 2 and lower than the IL. Again, this could be as a result of the presence of a binder film on the aggregate. Material B shows a better performance in year 2 but in a similar manner to the material on the M1 J5 SB decreases sharply in year 3; however, the values are maintained above the 0.55 IL.

Overall, the average CSC post-installation are comparable to the values reported pre-installation. However, as the post-installation data is limited, it is difficult to make any meaningful judgment on the performance of Material B.
