Ex Situ Cold Recycled Bound Material

Updates to DMRB CD 226
Stage 1.1.2 - Condition assessment

National Highways

22 November 2022

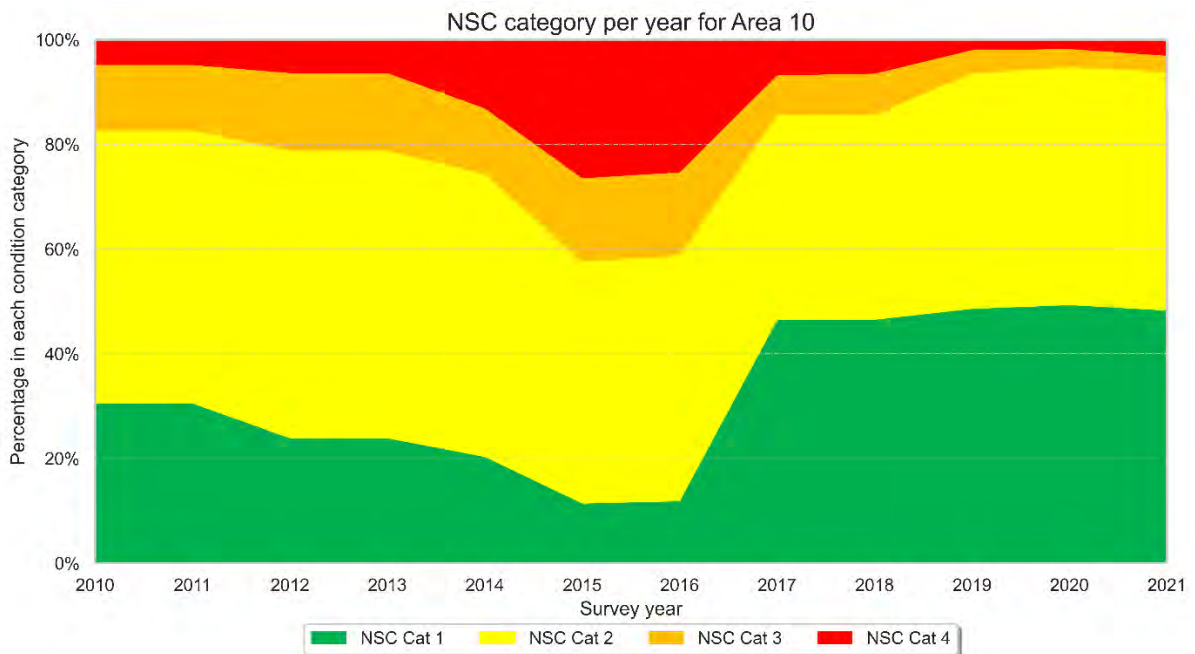
Figure 3.2 - NSC Category per year for 100 m sub-lengths of pavement in Area 10 (benchmark)

Comparing Figure 3.1 and Figure 3.2, it is apparent that in 2015 there was a significant increase in the NSC categories 3 and 4 reported (i.e. suggesting deterioration) across the SRN. However, the condition quickly recovered in subsequent survey years, which indicates that this is most likely a function of the survey analysis (i.e. a common TSD survey factor or perhaps a common environmental factor) rather than a deterioration in the pavement structural condition that was subsequently treated.

Based on Figure 3.1 and Figure 3.2, it can be concluded that:

- The NSC category indicates that the candidate CRBM sites are generally consistent with a typical in-service condition and not generally in need of structural maintenance.
- Typically less than 10% of CRBM is in NSC category 3 or 4 in any year, which is aligned with other pavement types on the SRN.

The structural condition of the CRBM sites appears to be broadly stable with the cumulative years and traffic in-service, and there is no apparent deterioration of the structural condition.

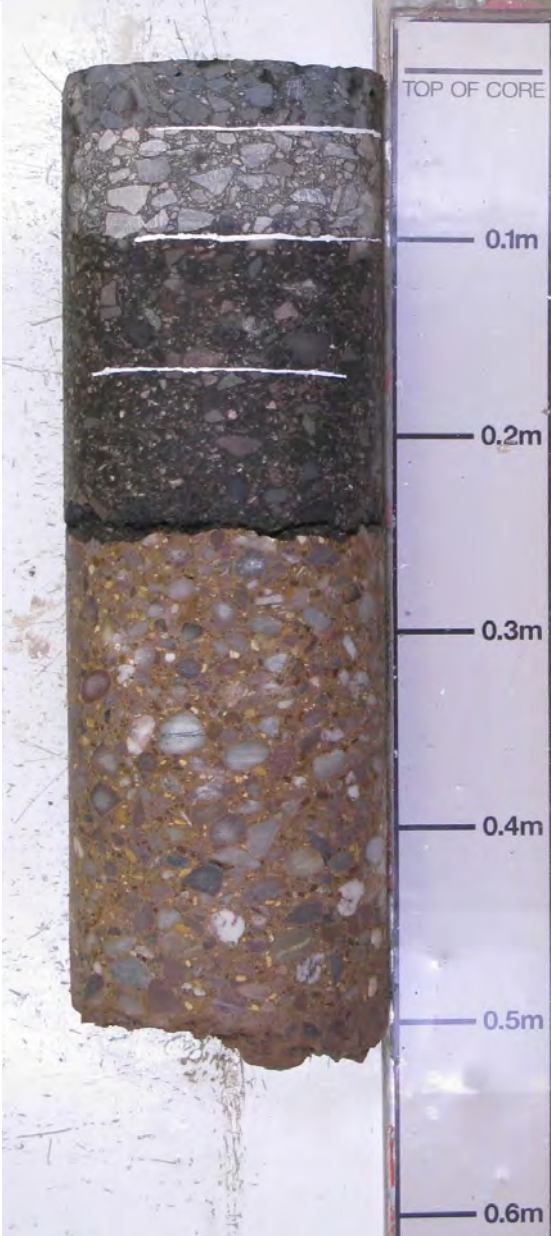
Layer	Depth (mm)		Thickness (mm)	Material Description ¹	Suitable for NAT/CS Testing (Yes/No)	PAK-Marker ²	Binder ³	Aggregate	
	From	To						Size ⁴	Type
1	0	35	35	Asphalt Surfacing	Yes	-ve	Bitumen	14	Crushed Rock
2	35	89	54	Asphalt Concrete	Yes	-ve	Bitumen	20	Crushed Rock
3	89	153	64	Asphalt Concrete	Yes	-ve	Bitumen	20	Crushed Rock
4	153	230	77	Asphalt Concrete	Yes	-ve	Bitumen	20	Crushed Rock
				Layers 4 & 5 Debonded After Extraction					
5	230	505	275	Concrete - Type B Voids	Yes	n/a	Cement	20	Crushed Rock
				Loose Granular Material Not Recovered

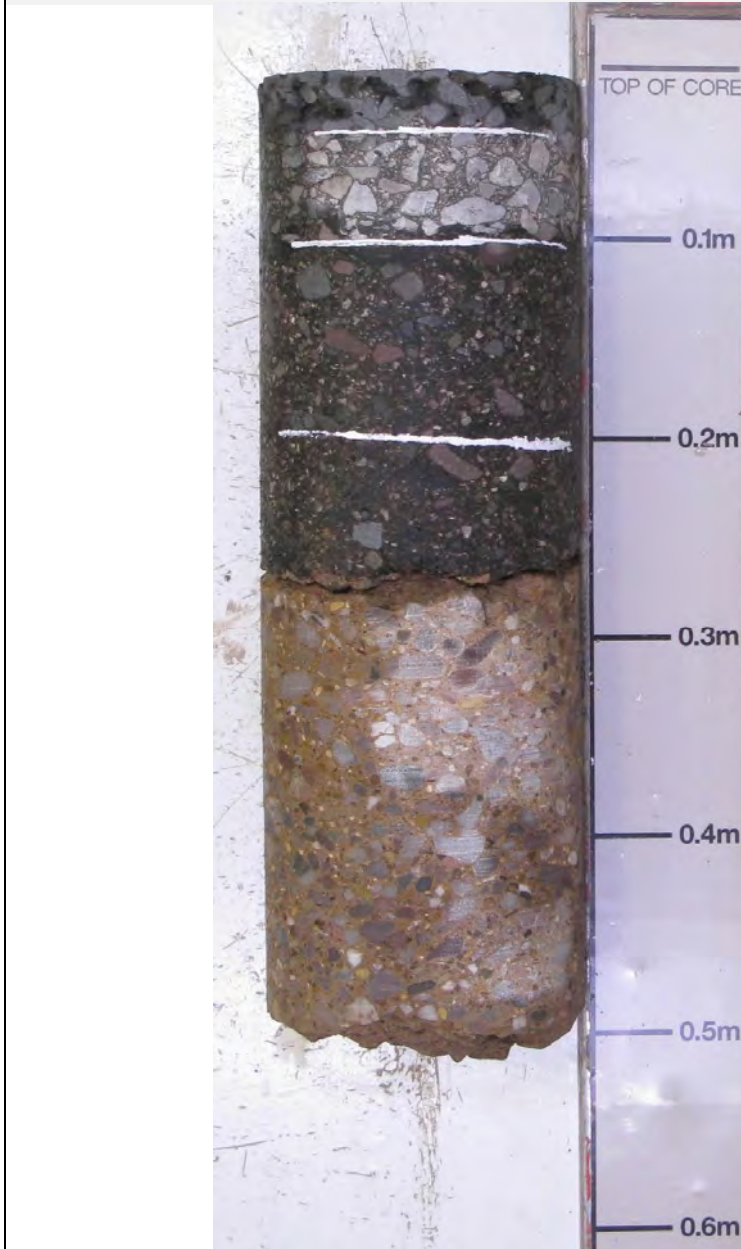
Layer	Depth (mm)		Thickness (mm)	Material Description ¹	Suitable for NAT/CS Testing (Yes/No)	PAK-Marker ²	Binder ³	Aggregate	
	From	To						Size ⁴	Type
1	0	30	30	Asphalt Surfacing (voided)	Yes	-ve	Bitumen	14	Crushed Rock
2	30	85	55	Asphalt Concrete	Yes	-ve	Bitumen	20	Crushed Rock
3	85	180	95	Asphalt Concrete	Yes	-ve	Bitumen	20	Crushed Rock
4	180	250	70	Asphalt Concrete	Yes	-ve	Bitumen	20	Crushed Rock
				Layers 4 & 5 Not Bonded					
5	250	490	240	Concrete - Type B Voids	Yes	n/a	Cement	20	Crushed Rock
				Loose Granular Material Not Recovered

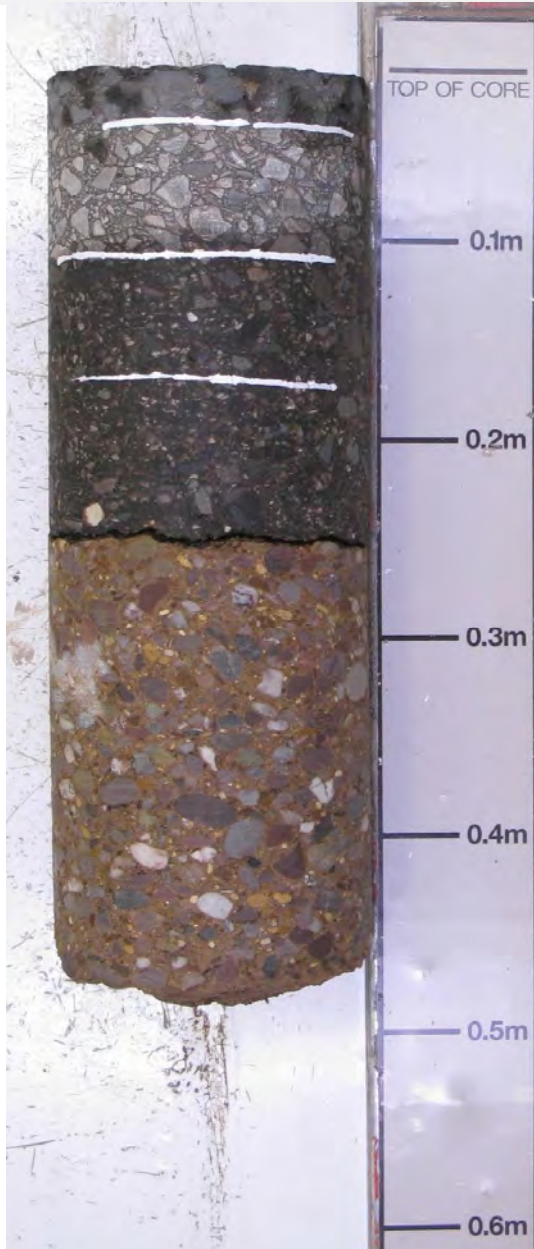
Layer	Depth (mm)		Thickness (mm)	Material Description ¹	Suitable for NAT/CS Testing (Yes/No)	PAK-Marker ²	Binder ³	Aggregate	
	From	To						Size ⁴	Type
1	0	28	28	Asphalt Surfacing	No	-ve	Bitumen	14	Crushed Rock
2	28	93	65	Asphalt Concrete	Yes	-ve	Bitumen	20	Crushed Rock
3	93	153	60	Asphalt Concrete	Yes	-ve	Bitumen	20	Crushed Rock
4	153	230	77	Asphalt Concrete	Yes	-ve	Bitumen	20	Crushed Rock
				Layers 4 & 5 Debonded After Extraction					
5	230	460	230	Concrete - Type C Voids	Yes	n/a	Cement	20	Crushed Rock
				Loose Granular Material Not Recovered

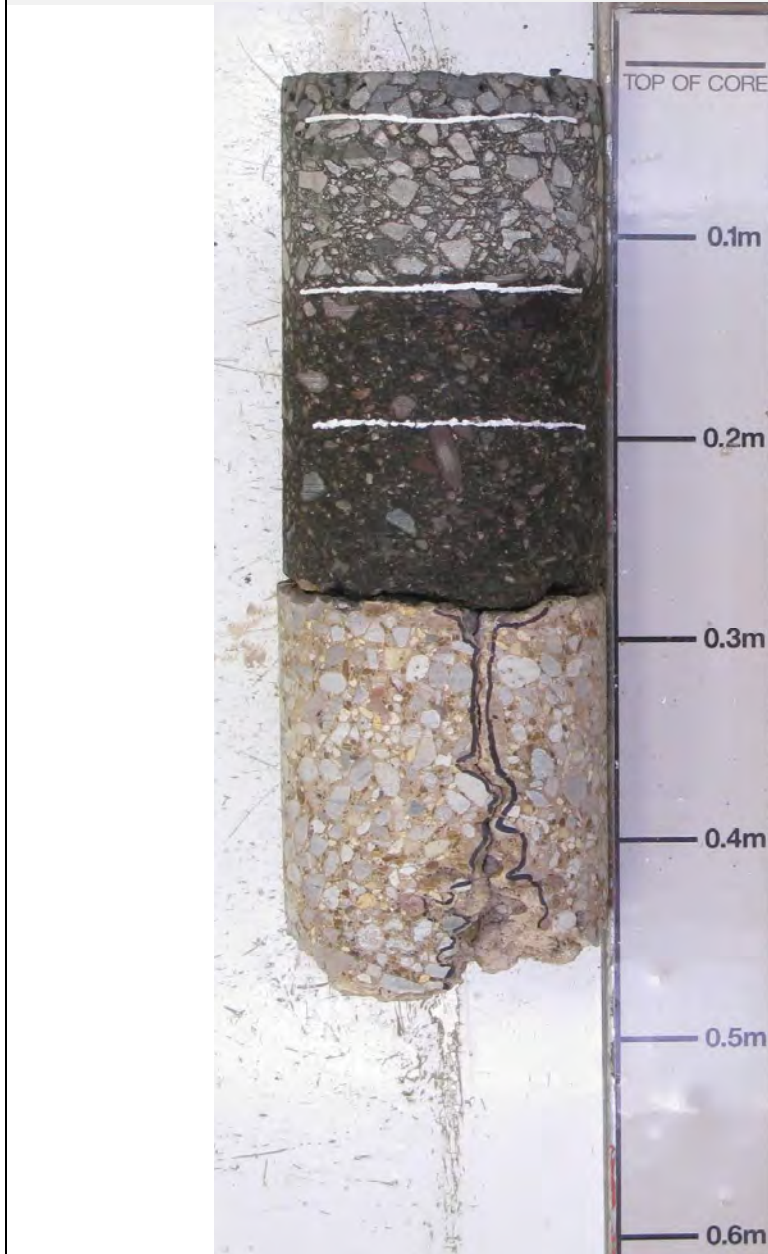
Job Number : 60598963	Scheme : University of Nottingham - A46 Stratford Northern Bypass
Sample Number : T - 1678	Location : Southbound, Lane 1 (CL1), NSWT, Offset from nearside white line 0.9m
Core Number : 04	HAPMS Ch. 3700A46/566+1500m
Cored / Logged By : KS / SD	OSGR: SP 17542, 55791
Date Cored / Logged : 15-04-19 / 29-04-19	Notes: Core located 2m after transverse crack
Nominal Diameter : 150mm

Layer	Depth (mm)		Thickness (mm)	Material Description ¹	Suitable for NAT/CS Testing (Yes/No)	PAK-Marker ²	Binder ³	Aggregate	
	From	To						Size ⁴	Type
1	0	24	24	Asphalt Surfacing	No	-ve	Bitumen	14	Crushed Rock
2	24	105	81	Asphalt Concrete	Yes	-ve	Bitumen	20	Crushed Rock
3	105	170	65	Asphalt Concrete	Yes	-ve	Bitumen	20	Crushed Rock
4	170	250	80	Asphalt Concrete	Yes	-ve	Bitumen	20	Crushed Rock
				Layers 4 & 5 Not Bonded					
5	250	455	205	Concrete - Type C Voids (in half)	No	n/a	Cement	20	Crushed Rock
				Loose Granular Material Not Recovered

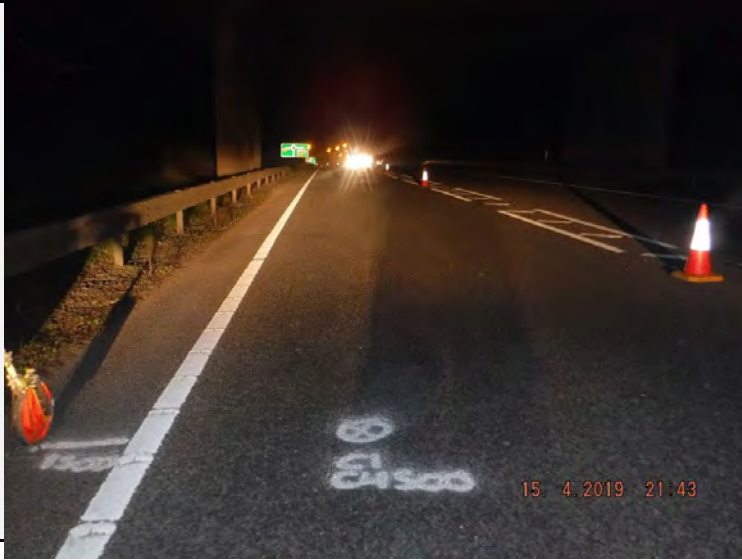
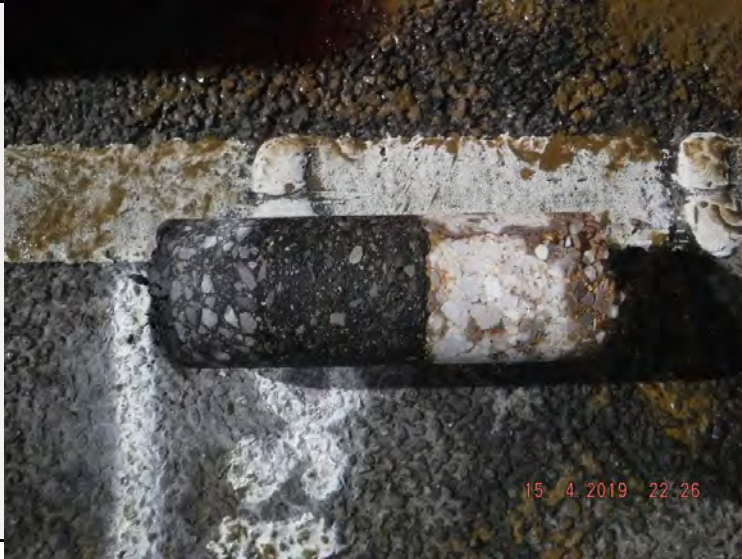
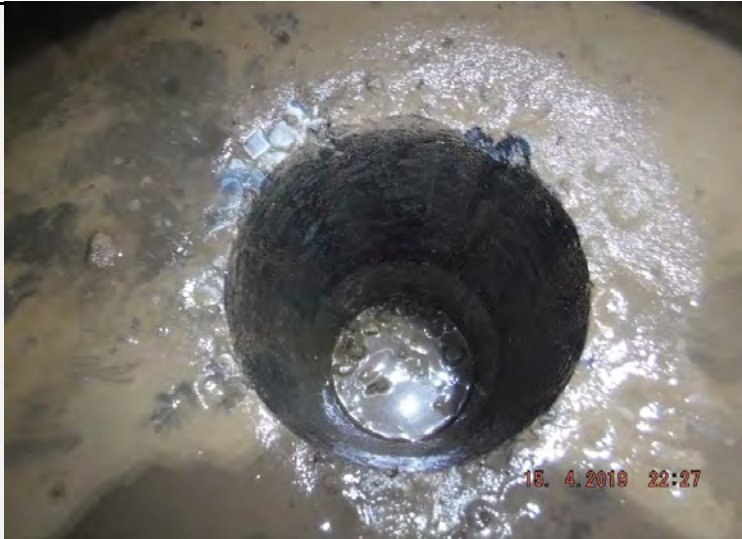
Job Number : 60598963	Scheme : University of Nottingham - A46 Stratford Northern Bypass
Sample Number : T - 1678	Location : Southbound, Lane 1 (CL1), NSWT, Offset from nearside white line 0.9m
Core Number : 04	HAPMS Ch. 3700A46/566+1500m
Cored / Logged By : KS / SD	OSGR: SP 17542, 55791
Date Cored / Logged : 15-04-19 / 29-04-19	Notes: Core located 2m after transverse crack
Nominal Diameter : 150mm

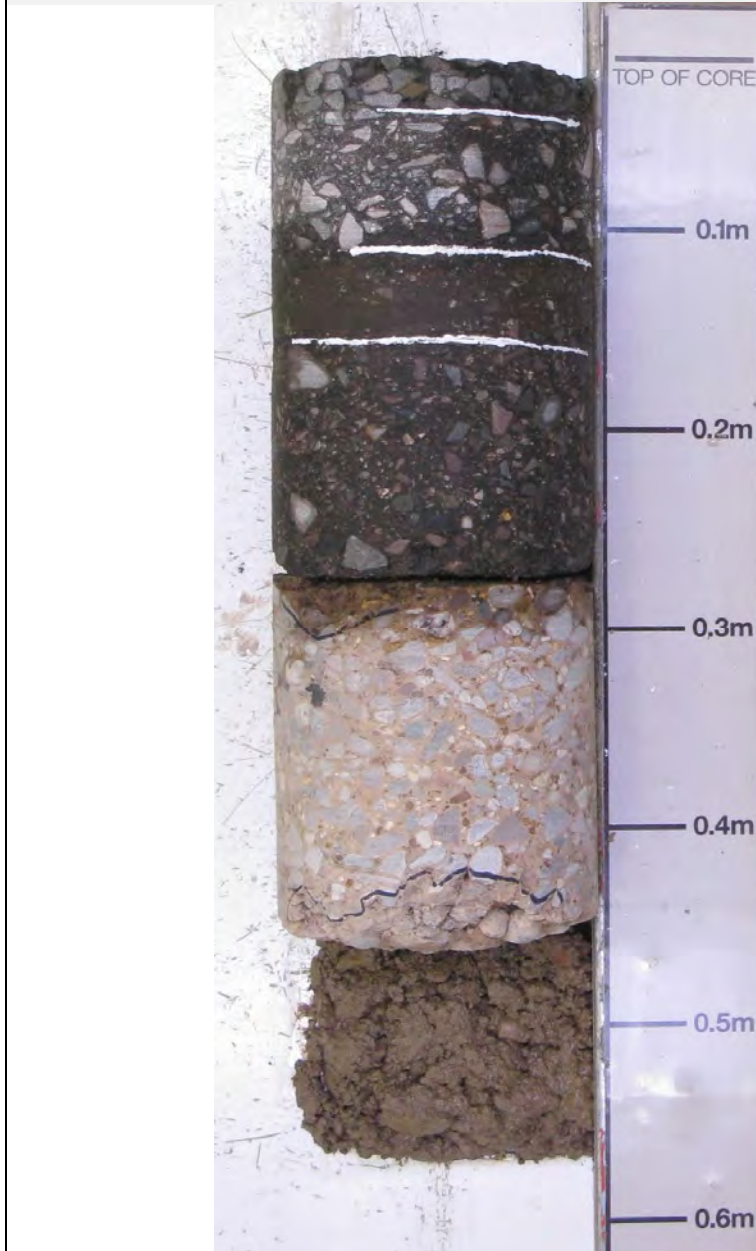
Layer	Depth (mm)		Thickness (mm)	Material Description ¹	Suitable for NAT/CS Testing (Yes/No)	PAK-Marker ²	Binder ³	Aggregate	
	From	To						Size ⁴	Type
1	0	26	26	Asphalt Surfacing	No	-ve	Bitumen	14	Crushed Rock
2	26	95	69	Asphalt Concrete	Yes	-ve	Bitumen	20	Crushed Rock
3	95	138	43	Asphalt Concrete	Yes	-ve	Bitumen	20	Crushed Rock
4	138	255	117	Asphalt Concrete	Yes	-ve	Bitumen	20	Crushed Rock
				Layers 4 & 5 Not Bonded					
5	255	445	190	Concrete - Type B Voids (broken @ base and top)	No	n/a	Cement	20	Crushed Rock
				Loose Granular Material

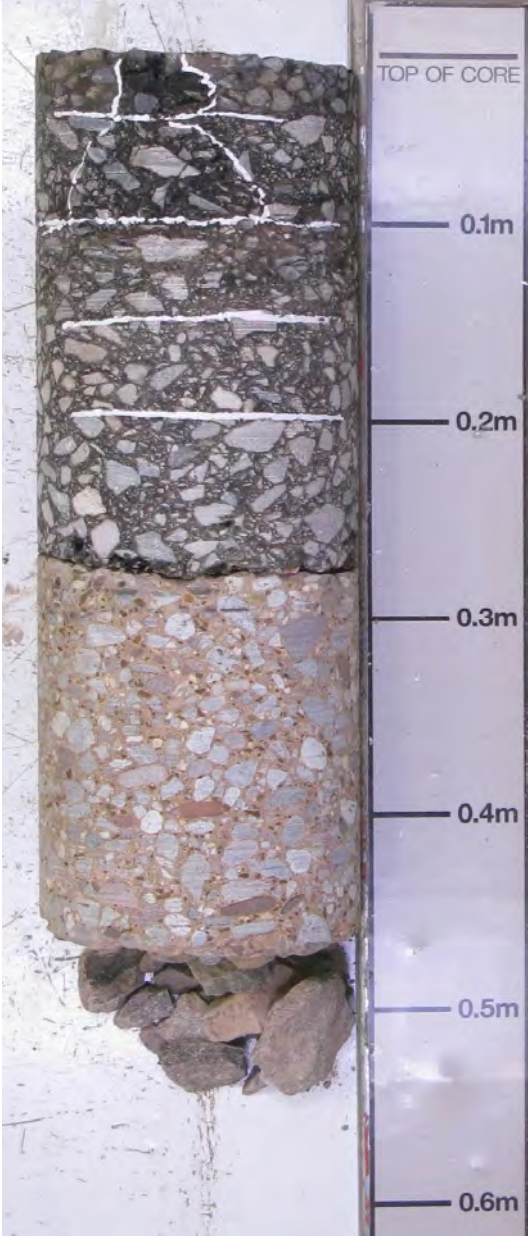
Layer	Depth (mm)		Thickness (mm)	Material Description ¹	Suitable for NAT/CS Testing (Yes/No)	PAK-Marker ²	Binder ³	Aggregate	
	From	To						Size ⁴	Type
1	0	31	31	Asphalt Surfacing (damage to face)	No	-ve	Bitumen	14	Crushed Rock
2	31	82	51	Asphalt Concrete (damage to face)	No	-ve	Bitumen	20	Crushed Rock
3	82	129	47	Asphalt Concrete	Yes	-ve	Bitumen	20	Crushed Rock
4	129	178	49	Asphalt Concrete	Yes	-ve	Bitumen	20	Crushed Rock
5	178	255	77	Asphalt Concrete	Yes	-ve	Bitumen	20	Crushed Rock
				Layers 5 & 6 Not Bonded					
6	255	470	215	Concrete - Type B Voids	Yes	n/a	Cement	20	Crushed Rock
				Loose Granular Material
